**INTERPUMP
GROUP**

KT16 - KT18 - KT20 - KT22 ***WK525 - WK530***

Repair manual

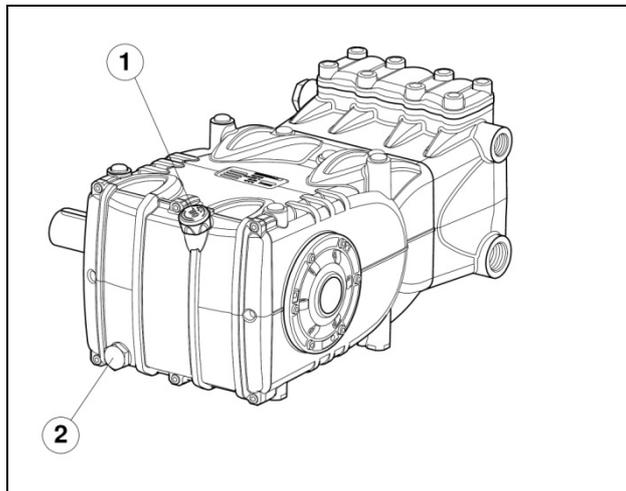
fig. 1

To remove oil, you must remove: the oil dipstick, pos. ① and then the plug, pos. ② , fig. 1.

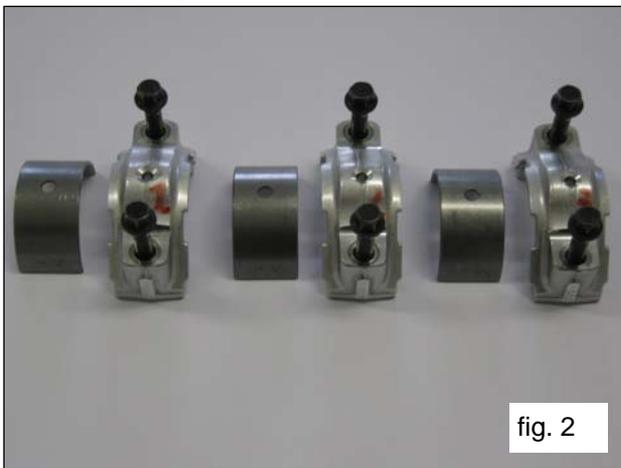
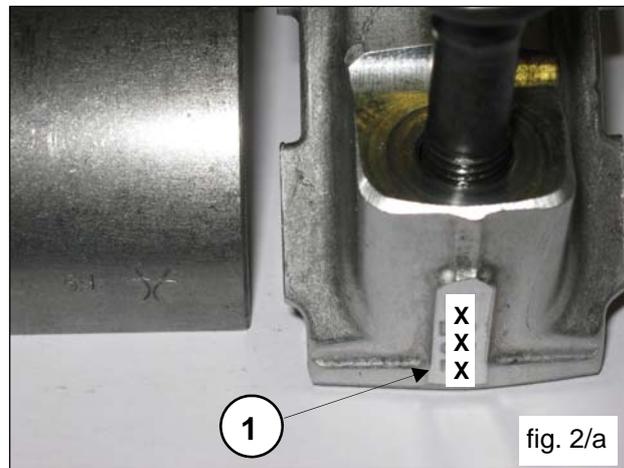
- the pump shaft tab
- the rear cover
- the con-rod cap as follows:
unscrew the cap fixing screws, remove the con-rod caps with their lower half-bearings (fig. 2) paying attention to the numbered sequence during disassembly.

To avoid possible errors, caps and con-rod shanks have been numbered on one side (fig. 2/a, pos. 1) .

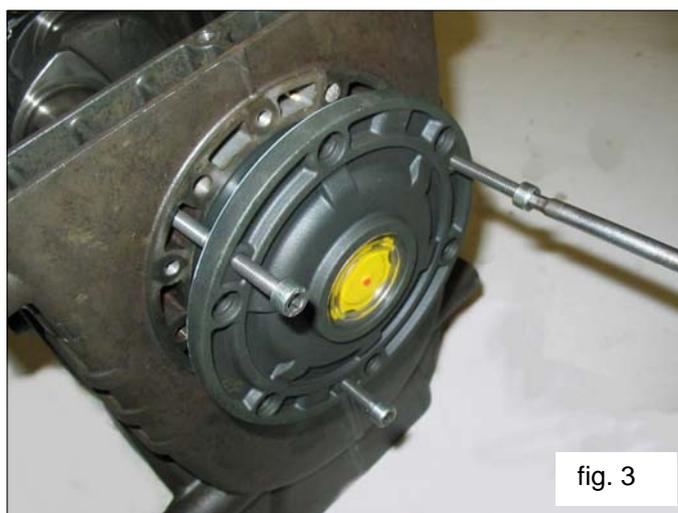
- the side covers using - for extraction 3 fully threaded M 6 x 50 screws, inserting them in the threaded holes as indicated in fig. 3

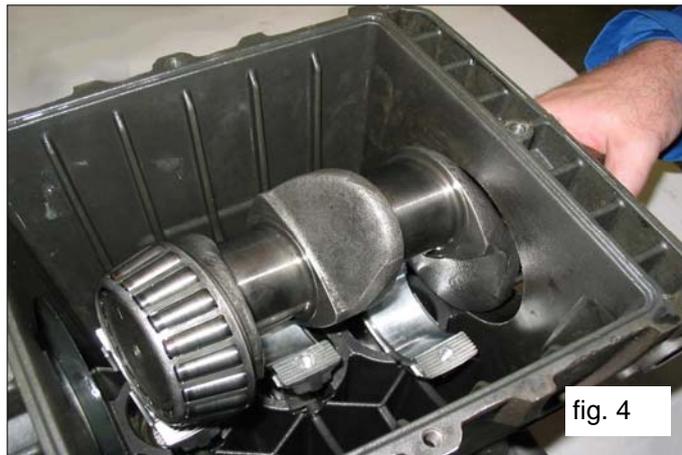
fig. 4

- Push the piston guides forward with their con-rods to facilitate side extraction of the pump as indicated in fig.4.

To facilitate pump shaft insertion (without the tab), it is essential to repeat the operation performed during disassembly, pushing the piston/con-rod guide units as far down as possible (para. 2.1.1).

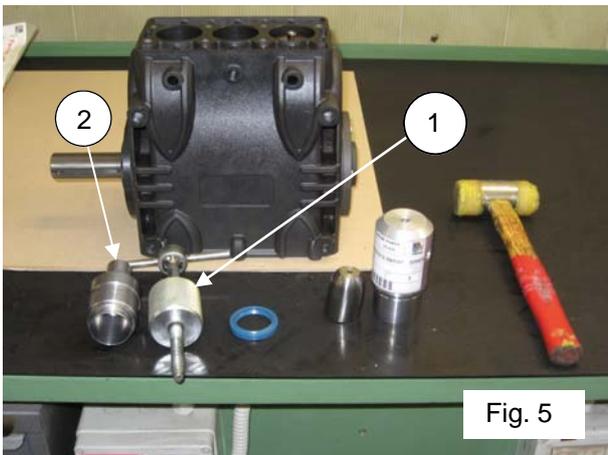
Fig. 5

Use the extractor, code 26019400 (fig. 5, pos. 1) and the gripper, code 27503800 (fig. 5, pos. 2). Insert the gripper as far as possible onto the seal ring with the aid of a hammer (fig. 5/a), subsequently screwing the extractor to the gripper, and use the extractor hammer (fig. 5/b) until the ring to be replaced is removed (fig. 5/c).

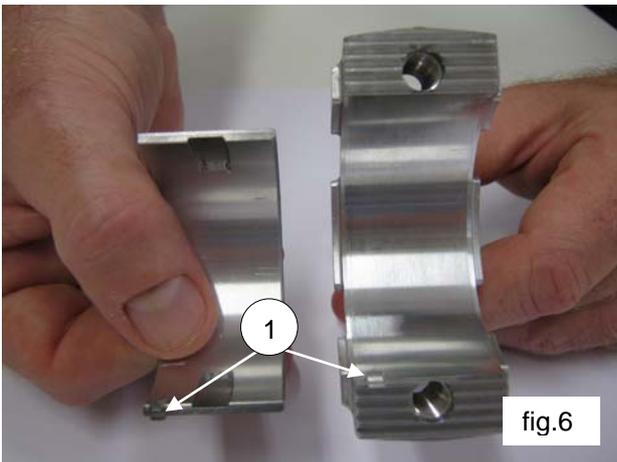
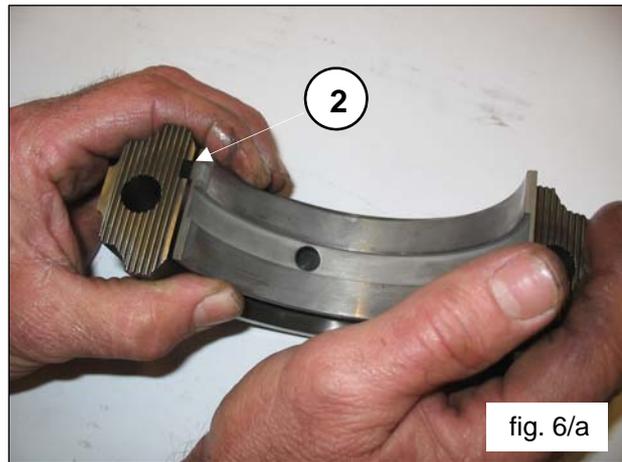
- Assemble the upper and lower half-bearings in their seats in the con-rods and caps.
Make sure that the reference marks on the upper half-bearings (fig. 6, pos. 1) and lower half-bearings (fig. 6/a, pos. 2) are positioned in their respective seats in the con-rod and cap.

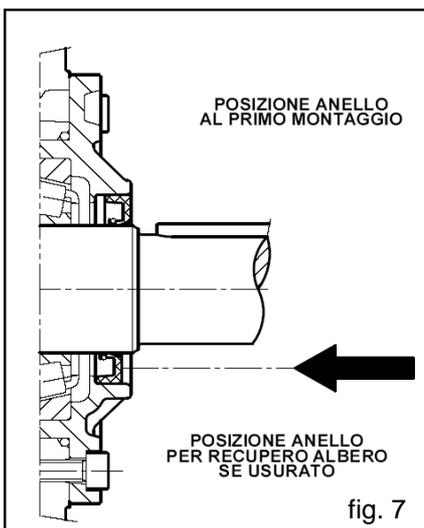
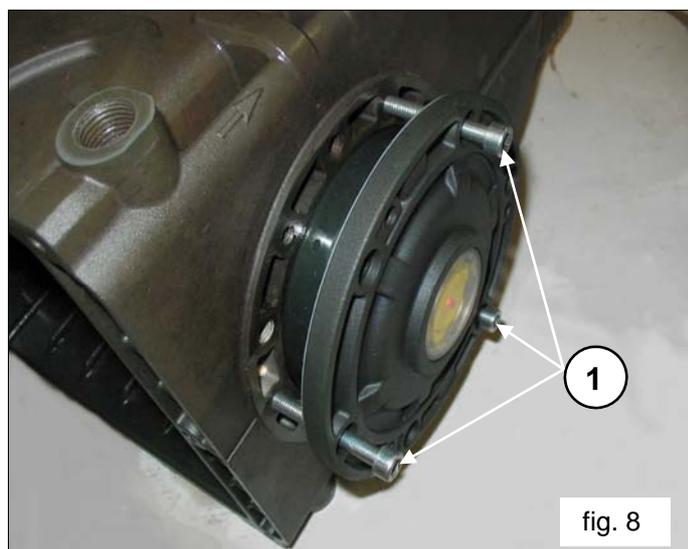
If replacement is necessary, position the new ring using a tool (code 27904500) as indicated in fig. 7.

If the pump shaft shows diametrical wear in the area of contact with the lip seal, in order to prevent the grinding operation, it is possible to reposition the ring in abutment with the cover as shown in fig. 7. Before assembling the side covers, make sure there are O-rings on both of them and shim rings on the indicator side cover only.

To facilitate filling of the first section and relative insertion of the covers on the casing, we recommend using three partially-threaded M6 x 40 screws (fig. 8, pos.1), then completing the operation with the screws supplied (M6x16).

To bring the two side covers closer to the casing, it is possible to use three M6x40 screws for the first positioning stage as described previously fig.8, and the screws provided for final fastening.

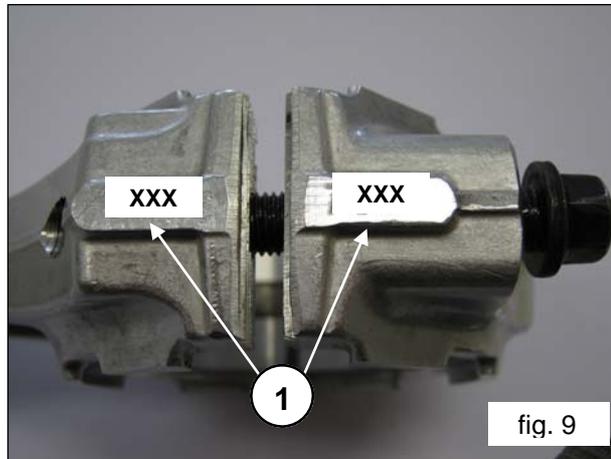
- Couple the con-rod caps to their shanks, referring to the numbering (fig. 9, pos.1).
Note the correct assembly direction of the caps.

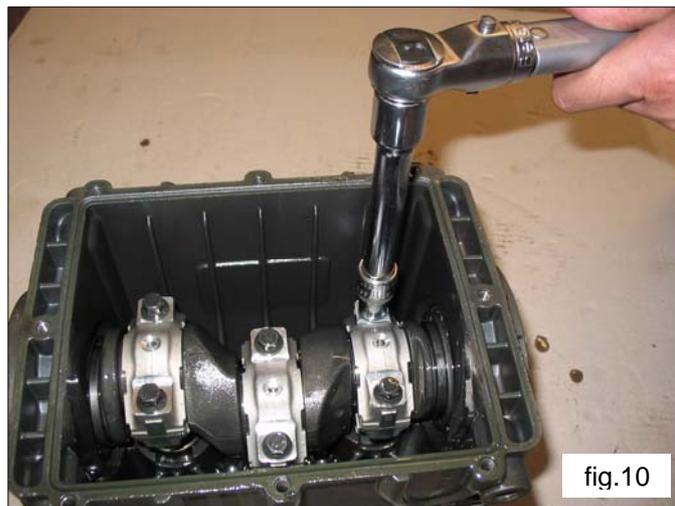
Fasten the caps to their respective con-rod shanks by means of M8x1x42 screws (fig. 10) lubricating both the underhead and the threaded shank, proceeding in two different stages:

1. **Manually turn the screws until they begin to tighten**
2. **Tightening torque 30 Nm**
Alternatively, ensure:
 1. **Pre-tightening torque 10-15 Nm**
 2. **Tightening torque 30 Nm**

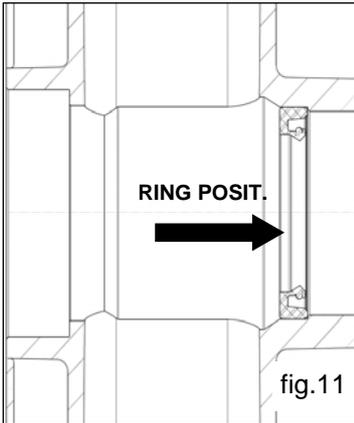
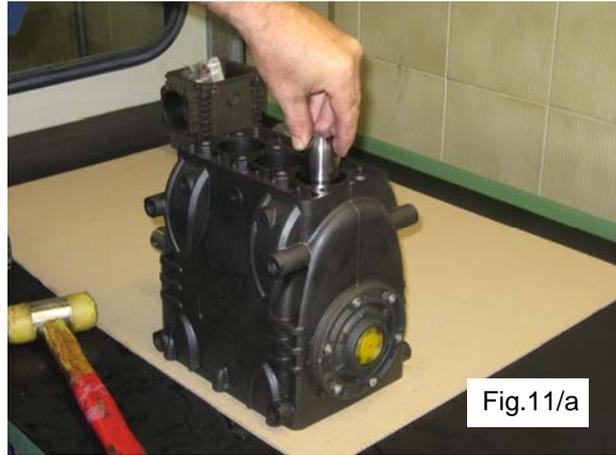
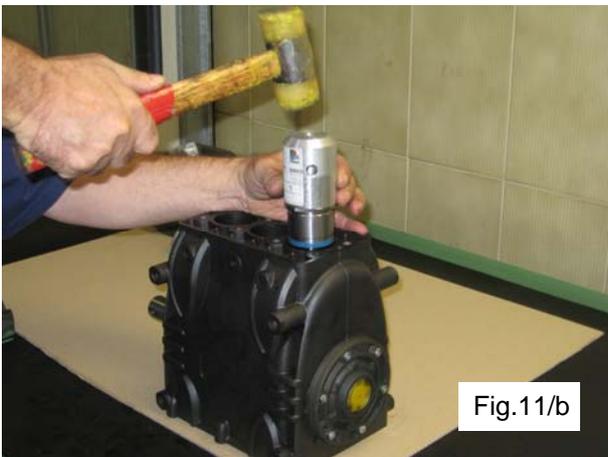
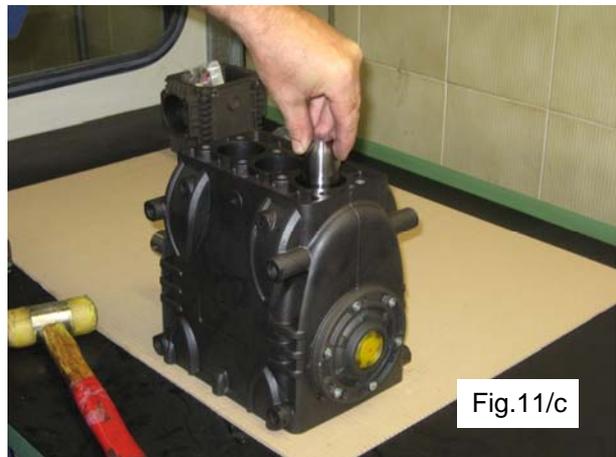
-Assemble the new piston guide seal rings with the relative seats on the pump casing (fig.11) following the procedure described:

using tool code 27904200 composed of a tapered bush and a buffer. Screw the tapered bush into the hole in the piston guide (fig. 11/a), insert the new seal ring on the buffer as far as it will go (determined by the height of the buffer) into its seat on the pump casing (fig. 11/b), remove the tapered bush (fig. 11/c).

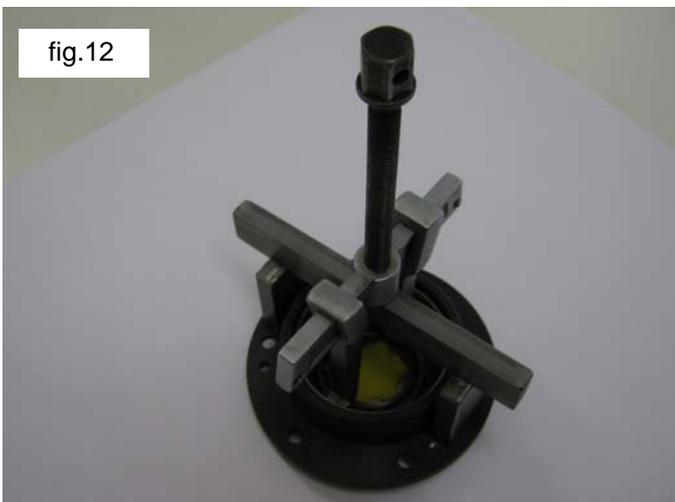
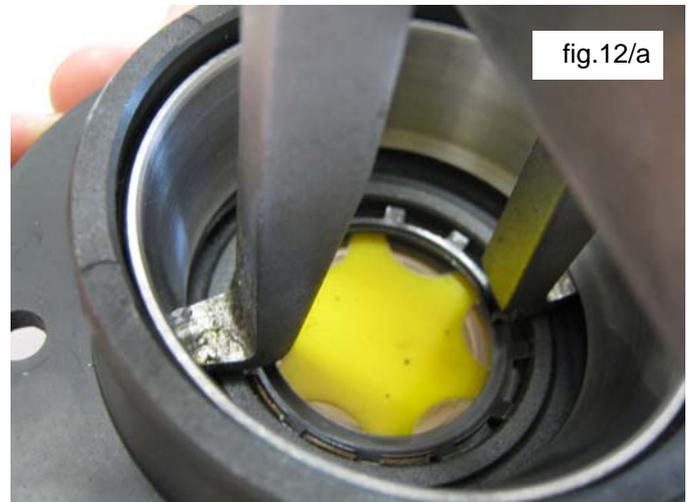
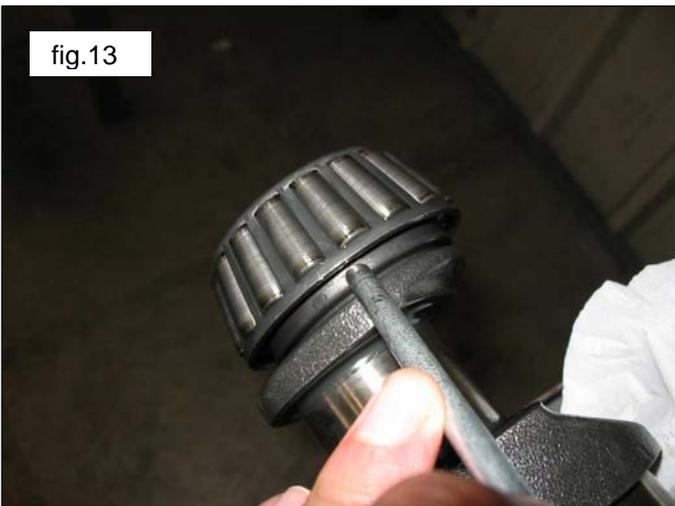
After removing the side covers, as described above, remove the outer ring nut on the bearings from its seat on the covers, using an appropriate extractor as shown in fig. 12 and 12/a.

Remove the inner ring nut on the bearings from the two ends of the shaft, again using an appropriate extractor or, alternatively, a simple "pin punch" as shown in fig. 13.

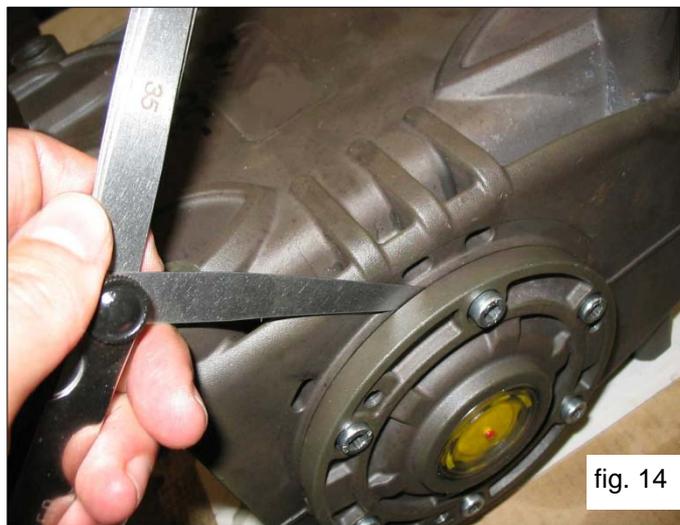
fig. 14

With the aid of a feeler gauge, measure the clearance between the side cover and pump casing (see fig. 14).

Proceed to determine the shim pack, using the table below:

Detected Measurement	Shim Type	# pieces
From: 0.05 to: 0.10	/	/
From: 0.11 to: 0.20	0.1	1
From: 0.21 to: 0.30	0.1	2
From: 0.31 to: 0.35	0.25	1
From: 0.36 to: 0.45	0.35	1
From: 0.46 to: 0.55	0.35 0.10	1 1
From: 0.56 to: 0.60	0.25	2
From: 0.61 to: 0.70	0.35 0.25	1 1

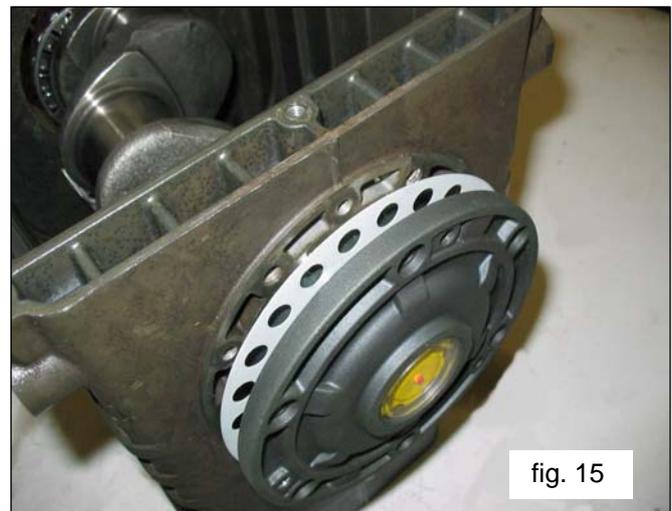
fig. 15

Once the type and number of shims have been determined using the table, check the following: assemble the shim pack on the indicator side cover centring (fig. 15), secure the cover to the casing, following the procedure in para. 2.1.2 and tighten the screws to their recommended torque.

Check that the shaft rotation stall torque is between 4 Nm and 6 Nm.

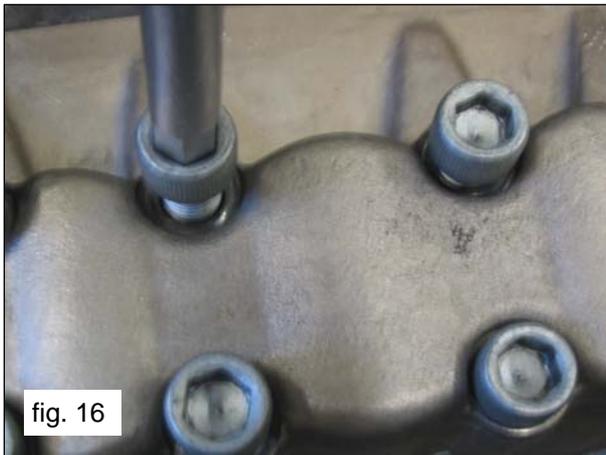
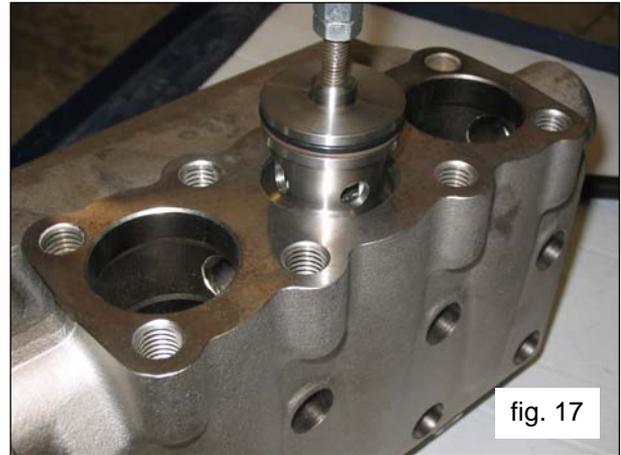
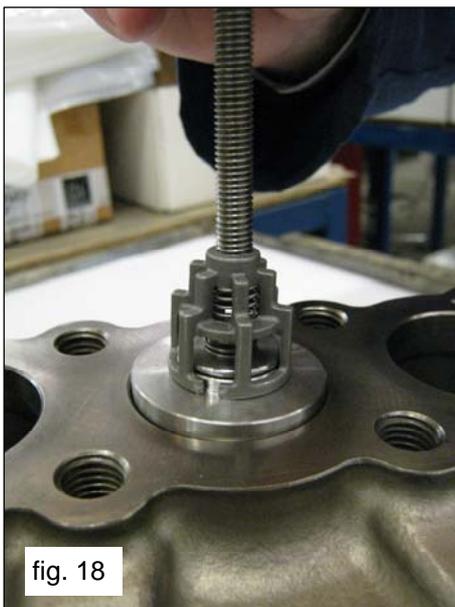
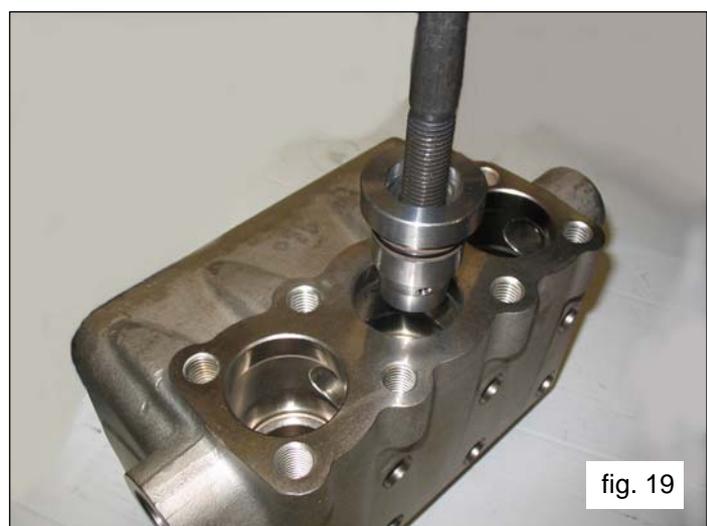
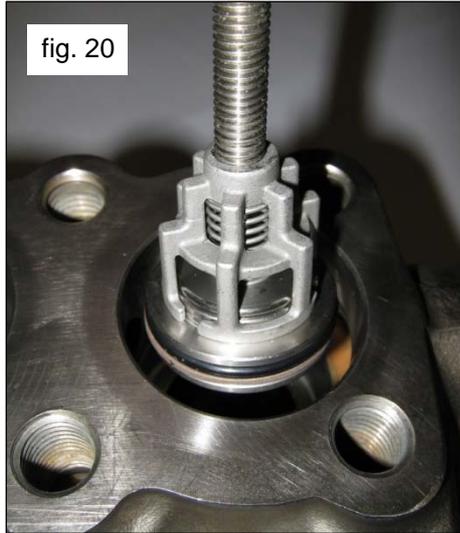
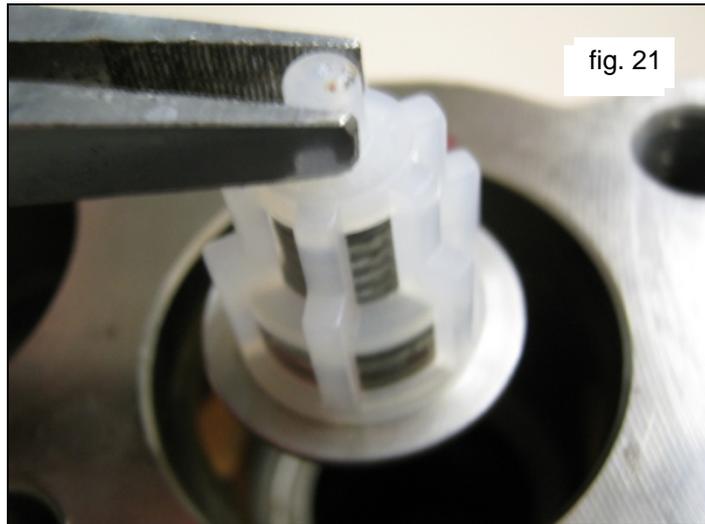
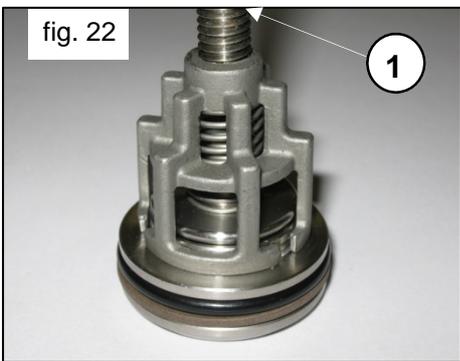
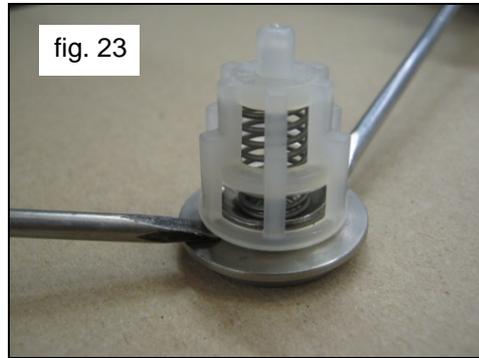
unscrew the 8 M14.40 valve cover fixing screws (fig.16).

Using the extractor hammer code 26019400, extract:

- A) Valve plugs (fig. 17)
- B) Outlet valve units (fig. 18)
- C) Valve bushes (fig. 19), combined with tool code 27513600
- E) Suction valve units (fig. 20)

while for the KT16-KT18-WK525-WK530 pump outlet valve units, being without threading for extraction, should they remain glued in place on the head, use a simple tool as indicated in fig.21.

Disassemble the suction and outlet valve units, screwing a sufficiently long M8 screw in such a way as to be able to reach the valve plate and extract the valve guide from the seat, fig. 22, pos. 1.
If the M8 threaded holes should not be present on the valve guide, dismantling can be easily carried out by leveraging with simple tools fig. 23.

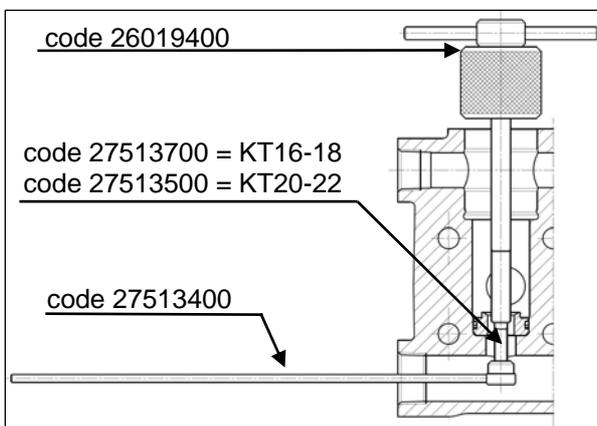
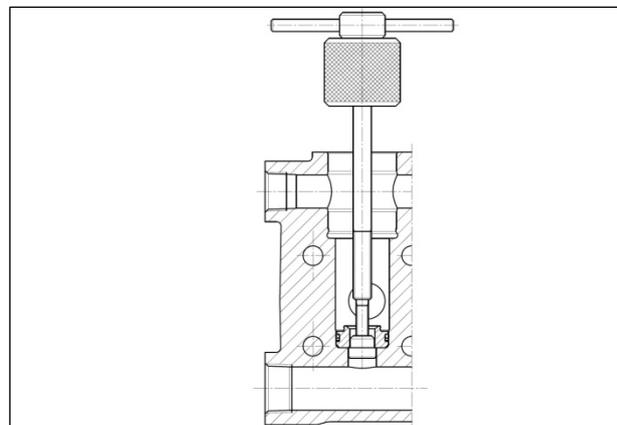
fig. 24

For KT 16-18 versions use tools code 26019400, code 27513700, code 27513400, (fig. 23, 23/a).
For KT 20-22 versions use tools code 26019400, code 27513500, code 27513400, fig. 24, 24/a.

Note: Before extracting from the seats, always unscrew the handle code 27513400

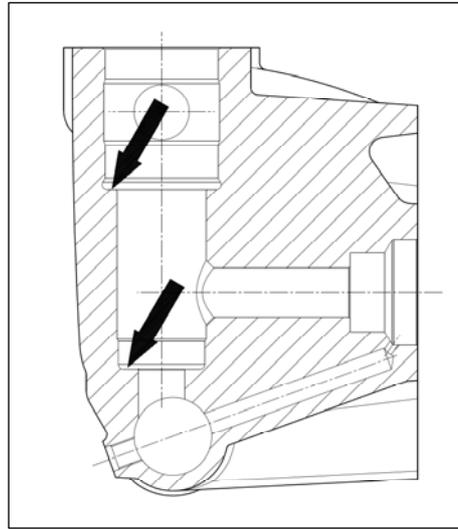
fig. 25

Before repositioning the valve unit, thoroughly clean and dry the relative seats in the head as indicated in fig. 25.

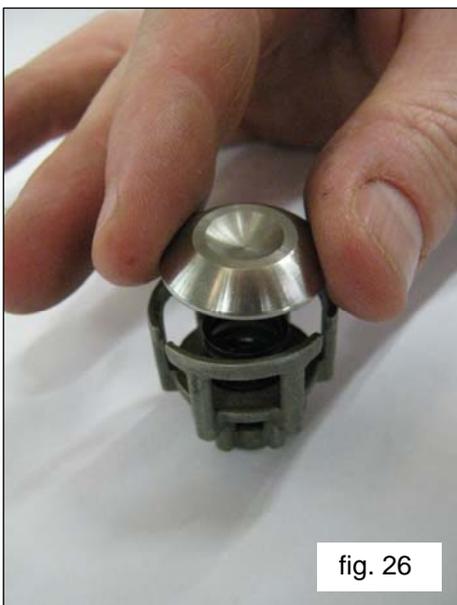
fig. 26

1. **Do not invert the suction springs with the previously disassembled outlet springs fig.26, 27**
On pumps KT20 and KT22, take special care not to invert the suction springs with the previously disassembled outlet springs:
 - a) "White" suction spring
 - b) "Black" outlet spring

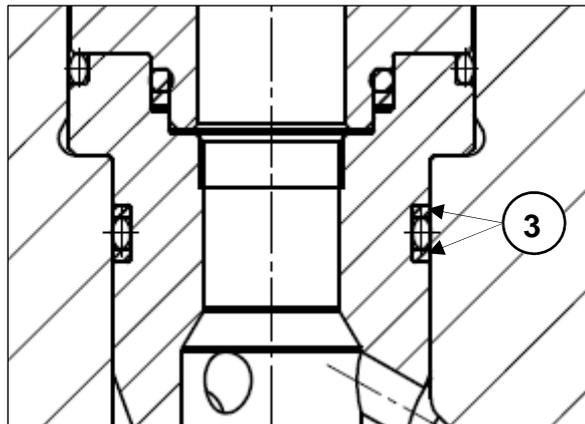
fig. 28

Insert the suction and outlet valve units, checking that they are down to end stroke in the head. Take special care not to damage the anti-extrusion rings on the bushes (fig.28, pos. 3). For correct positioning and adjustment of rings in their respective seats:

- Insert the bushes completely in the head, lubricating the external OR/anti-extrusion rings diameter with OCILIS type silicone grease code 12001600.
- Remove the bushes, verifying the integrity of all the anti-extrusion and OR rings.
- Proceed with final reassembly.

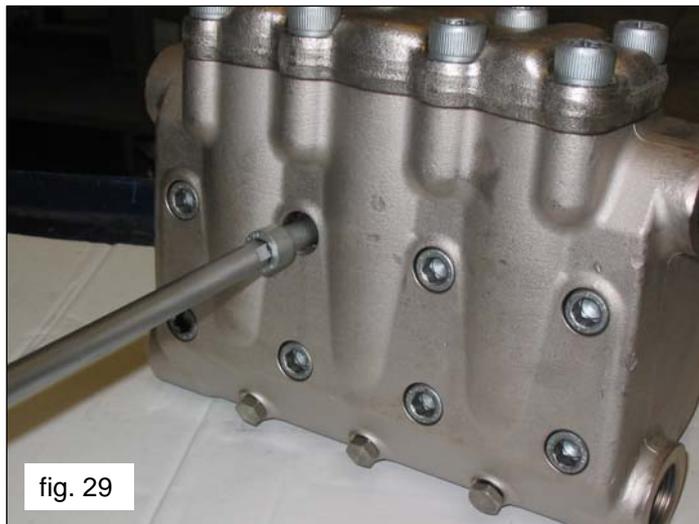
A) Unscrew the M10x140 head fixing screws as indicated in fig. 29.

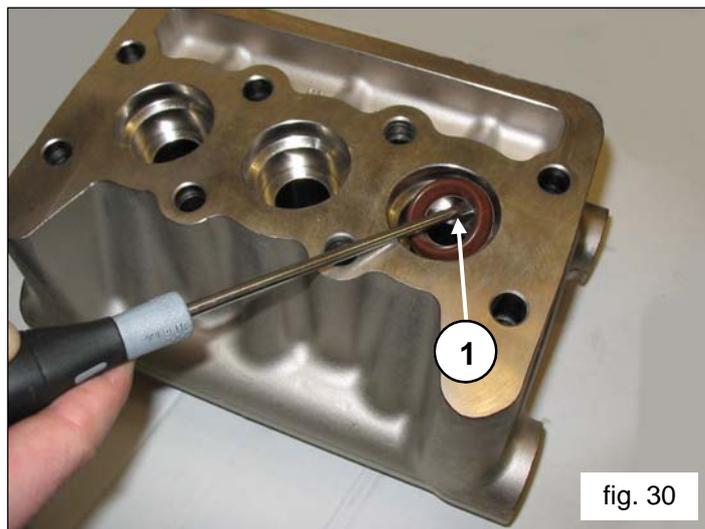
C) Extract the high pressure seals from the head and the low pressure ones from the support, using simple tools as indicated in fig. 30, pos.1, being careful not to damage the respective housings.

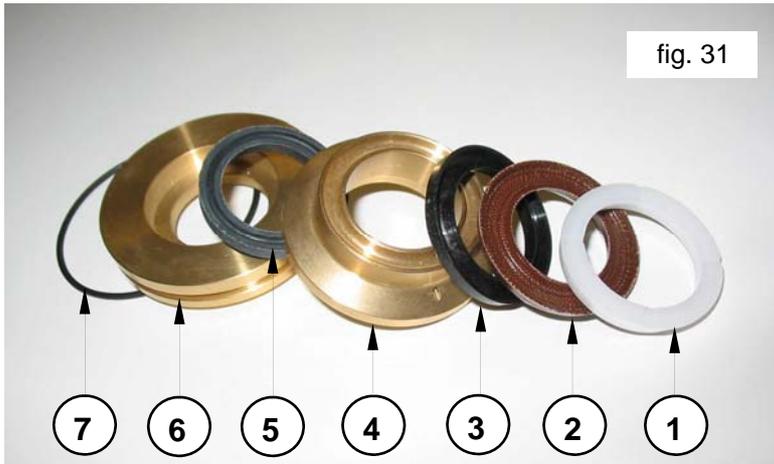
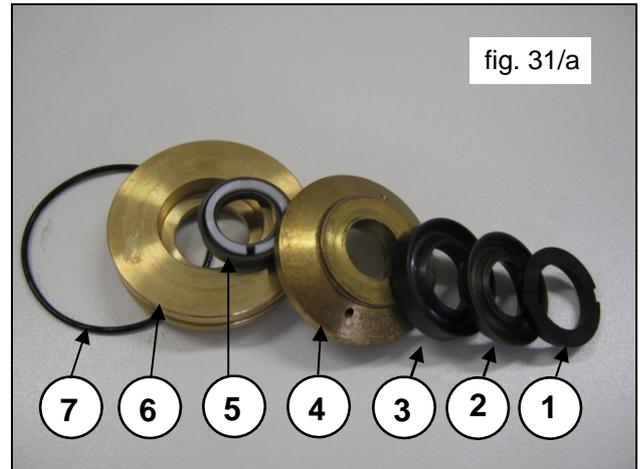
Pay attention to the order of seal pack disassembly as indicated in fig.31 for KT 20- KT22 version pumps and in fig.31/a for KT18 version pumps, composed of:

1. Head ring
2. HP seal
3. Restop Ring
4. Seals support
5. LP Seal
6. Seal ring
7. OR ring

- A) Seals pack: respect the same order used during disassembly operations.
- B) Lubricate components ②③⑤ with OCILIS silicone grease code 12001600; this operation is also deemed necessary to facilitate adjustment of the lip seal on the piston.

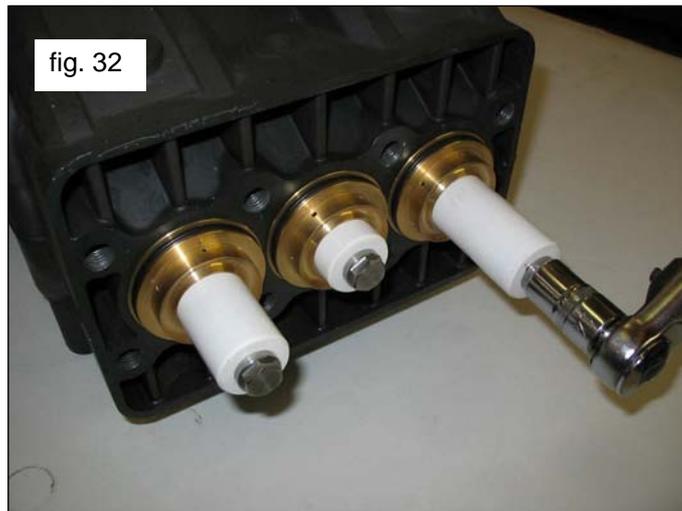
The piston unit does not require any routine maintenance. Maintenance is limited to visual checks only. To extract piston units: Loosen the M 7x1 piston fixing screws as indicated in fig. 32.

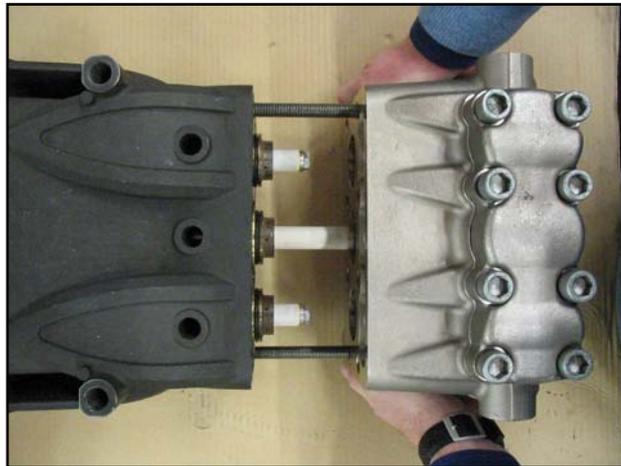
fig. 33

- 1. Position the seal supports in the respective seats on the casing.
 - 2. Using two screws – service pins (code 27726000), fasten the casing as indicated in fig. 33. Position the complete head, making sure that it is centred only on the central piston.

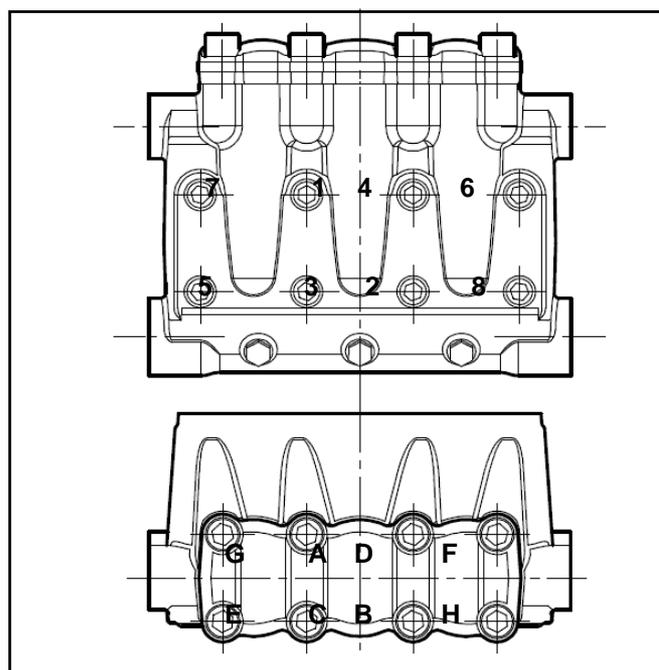
Fig. 34

** The head fixing screws explod.. Pos. 47 must be tightened with a torque wrench respecting the order shown in the diagram in fig.34.

* * * The valve cover fixing screws explod. pos. 45 must be tightened with a torque wrench respecting the order shown in the diagram in fig.34.

DESCRIPTION	EXPLODED POSITION	TIGHTENING TORQUE (Nm)
Cover fixing screws	9	10
Oil discharge plug	11	40
Piston fixing screws	27	20
Con-rod cap fixing screws	18	30 *
Valve cover fixing screws	45	180 * * *
Head fixing screws	47	80 * *
"A" type flange fixing screws	86	22
SAE C drawbar coupling fixing screws	88	40
2nd PTO flange fixing screw	96	145* * *
